# An Investigation of Internal Corrosion of Oil and Gas Transporting Carbon Steel Pipes in the Niger Delta Area of Nigeria

Obotowo W. Obot and Charles N. Anyakwo

**Abstract**—Internal corrosion of carbon steel pipes of oil and gas Companies in the Niger Delta area of Nigeria using coupons and ER probes is presented. Corrosion mechanisms for the lines vary with the fluid type and operational parameters. Aqueous corrosion with, in some cases CO<sub>2</sub> corrosion additive, erosion corrosion and elevated temperature oxidation are corrosion mechanisms implicated in the pipes. No H<sub>2</sub>S-induced corrosion was observed for all the lines investigated. They act separately or synergistically to exacerbate the corrosion attack. Application of inhibitors of the amine group drastically lowered the corrosion rates. Effective inhibition regime had in an instance markedly lowered the corrosion rate of a line from 42.7080mpy to 1.3447mpy. The ER probes incorporation offered a comparative corrosion monitoring alternative and provided insight into the real time conditions of the lines over prolonged periods of times. The exercise proved very useful in determining the corrosion status of

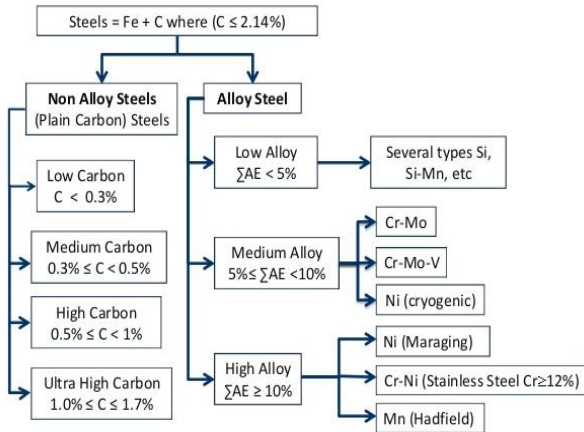
other elements are allowed in carbon steel, with low maximum percentages. These elements are: Mn, 1.5-1.65% max., Si, 0.5- 0.60% max., and Cu, 0.60% max. Other elements may be present in quantities too small to affect its properties. Low and medium carbon non alloy steels are commonly used in the manufacture of steel pipes [8]-[10], Fig. 1.

Fig.1. Composition of steel [11].

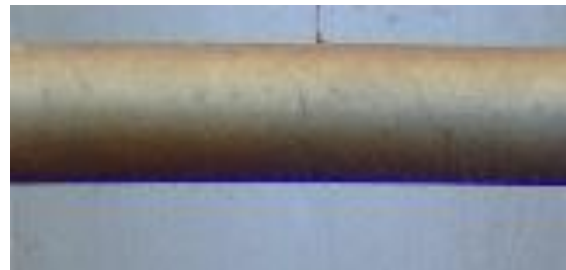
Fig. 1. Horizontal pipe

The Corrosion Monitoring Points (CMPs) were preferentially installed on the horizontal sections and in the areas of depressions where “dead leg” corrosion is most likely to take place (Fig.1). Few CMPs are located on vertical segments of the lines (Fig. 2), elbows and bends, etc., that are usually prone to erosion corrosion were more regularly monitored for thickness variations using NDT techniques.

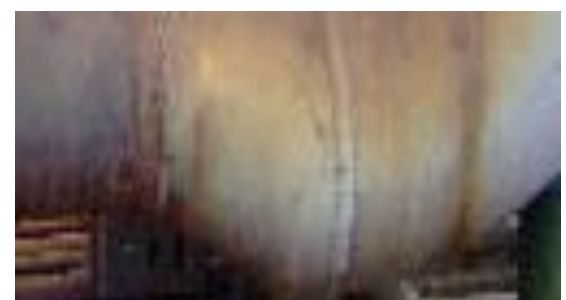
Fig.2. Segment with a bulge where “dead leg” corrosion could be encouraged

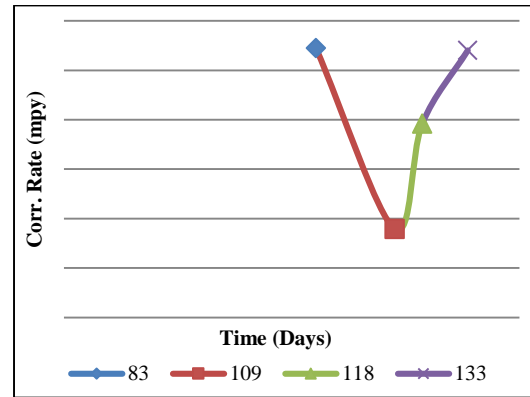
Fig. 5 to 7 presented troughs and subsequent corrosion rate increases. These are indicative of fluctuations in fluid concentrations and changes in operational parameters.

Fig. 5. Corrosion rates for coupons wholly extracted at different times for CMP 10 (6in. diam. glycol dehydration regeneration gas inlet to fan cooler)

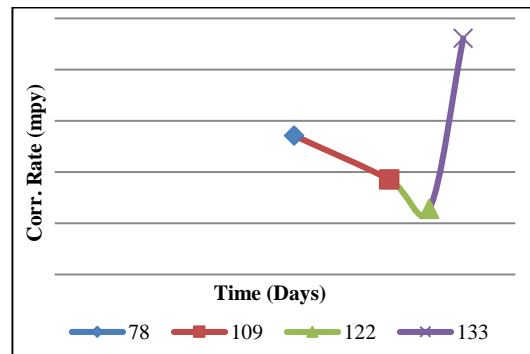
Fig. 6. Corrosion rates for coupons wholly extracted at different times for CMP 06 18in. Gas Inlet Line

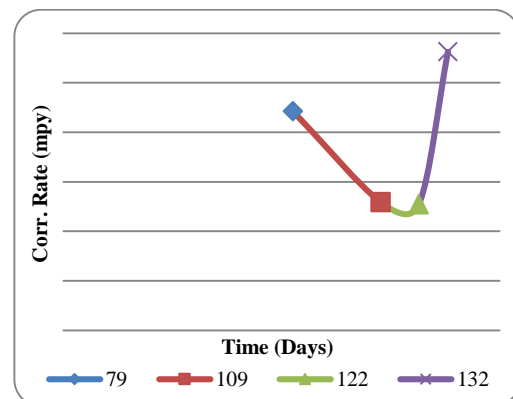
Fig. 7. Corrosion rates for coupons wholly extracted at different times for CMP 08 (24in. Gas arrival Line)

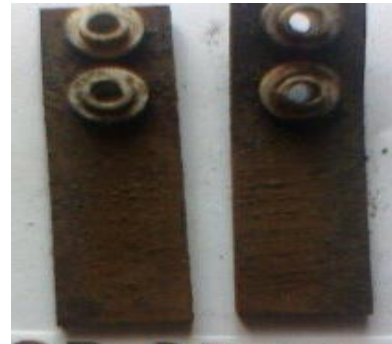
Fig.9. CMP 05; coupons immersed in recirculation water line. View immediately after extraction, campaign 1, dark brownish scales and water covering; average corr. rate, 2.7472 mpy

Understandably the coupons in contact with water, Fig. 9, showed relatively highest corrosion rates. The rate was as high as 5.0748 mpy but was effectively reduced to 2.7472 mpy by corrosion inhibitor application.

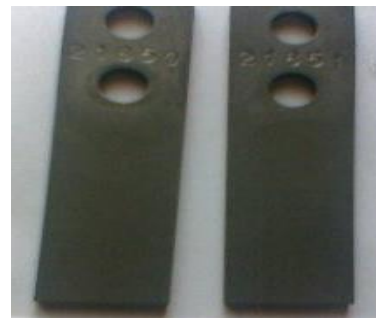
Fig. 10. CMP 09; gas medium; Smooth, waxy, ash coupons' surfaces, Corr. rate, 0.2033 mpy. View immediately after extraction.

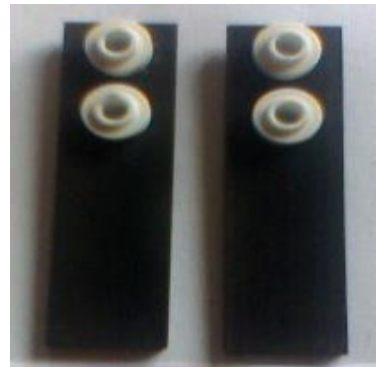
Fig. 11. CMP 07; gas medium; Dark sooty film with slight brownish superimposition, Corr. Rate, 0.4110 mpy, 0.3769mpy; View immediately after extraction.

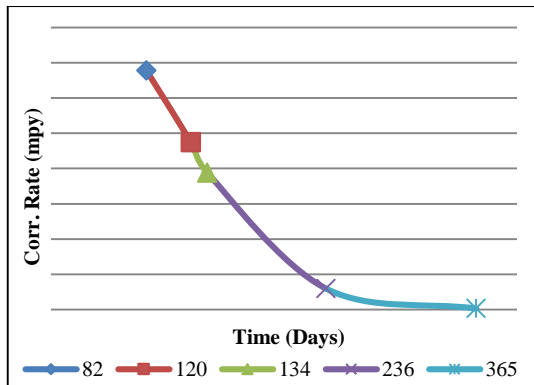
Furthermore, they provide data for the real time corrosion analyses of lines over extended periods of time. For the majority of the lines the corrosion rates tend to zero for long periods of about six months and more. This is indicative of active passivation of the lines by the tenaciously adhering corrosion films and explains why most of the lines have held out for over twenty years without the incidence of significant leakages or breakouts. A representative figure of this scenario is given in Fig. 12.

Fig 12. Modification of fig. 4; Corrosion rates for coupons extracted and analyzed at different times and merged with one ER probe corrosion rate figure (last point at 365 days); for CMP 28 (Well 25L Gas Line)

The ER probe corrosion rate figure for CMP 28 has been incorporated into Fig. 4 to obtain Fig.12.
